TRAFFIC ENGINEERING STUDY Red Light Running Camera Evaluation Analysis EB & WB US 290 Service Roads at FM 529 Jersey Village, Texas

Engineer of Record: Robert B Zaitooni, PE, PTOE Texas Registration No. 98003 September 2018

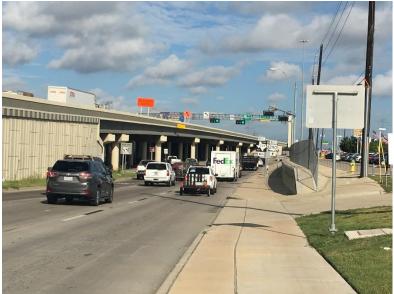
Figure 3. WB US 290 Service Road Approach

The WB approach is located downstream of the US 290 westbound off ramp and consists of 3 lanes (2 through & 1 left turn) with curb and sidewalk as shown in Figure 2. FM 529 forms a "T" intersection with the WB approach.

Signal Visibility – Signal heads are visible from 1000'+ which is more than the MUTCD requirement of 390', as shown on Table 4D-2 below for posted speed of 40 mph. A "signal ahead" sign is installed at approximately 1000' back from the stop bar. The traffic signal heads are horizontal-mounted and include "tunnel visors" and "backplates" for maximum visibility.

Pavement Conditions - A visual inspection of the pavement condition at the intersection showed no signs of significant wearing or cracking that could inhibit a driver's ability to stop while approaching the intersection. All required pavement marking (i.e. stop bar, lane lines, arrows, crosswalks) are aged but visible. Crosswalk striping on the west side of the intersection is missing. Signing is adequate and in conformance with MUTCD.

Vehicle Detectors – three (3) sets Loop sensors are installed in the pavement on this approach. 6' x 20' presence sensors are installed at the stop bar in all lanes, 6' x 6' advance pulse sensors are installed at approximately 110' from the stop bar and at 240' from stop bar. Pedestrian signal heads are installed for all permitted crossings.

Signal Operation – This signal is located approximately 0.41 miles from Senate Avenue signal, along WB US 290 Service Road. Arrival at the signal is mostly random due to the freeway ramp merge 500' back. Long queue of vehicles were observed for several cycles in the morning, back to the freeway ramp. Signal phasing does not appear to be a contributing factor to red light running, however, signal timing seems to cause unnecessary delays for the approach.

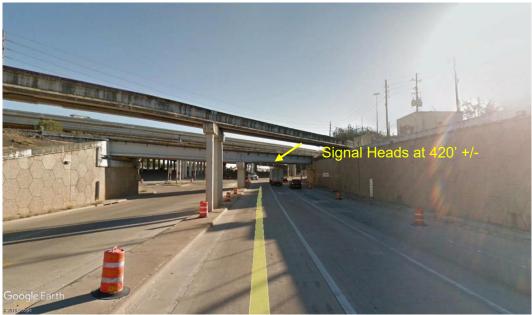
Figure 6. NB Senate Avenue Approach

This approach to the intersection has 4 lanes (2 through & 2 right turn) and posted speed of 45 mph. The profile of the approach is on a long down-grade with overhead structures which limit sight visibility to the signals, as depicted on Figure 6 & 7.

Signal Visibility – The vertical down-grade in conjunction with 2 bridge overpasses on the approach, block sight to the signal heads. The signal heads are visible from approximately 430', which is less than 460' requirements for 45 mph. This route is heavily used by trucks which further restrict visibility on the approach. There is no "signal ahead" sign for the approach and installation is recommend as soon as possible.
