TRAFFIC ENGINEERING STUDY Red Light Running Camera Evaluation Analysis EB & WB US 290 Service Roads at Senate Avenue Jersey Village, Texas

TRAFFIC ENGINEERING STUDY

Red Light Running Camera Evaluation Analysis EB & WB US 290 Service Roads at Senate Avenue Jersey Village, Texas

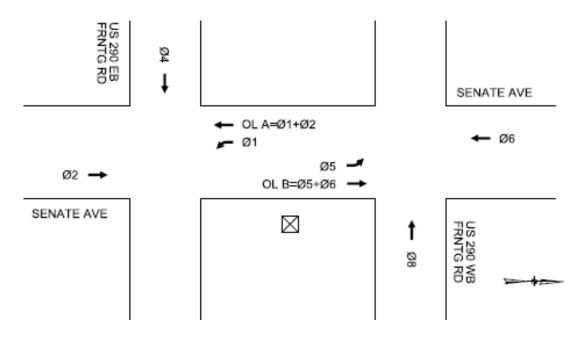
Figure 2. Traffic Signal Phasing

As shown on Figure 1, Senate Avenue passes under US 290 (also known as Northwest Freeway) mainline; and intersects the EB & WB US 290 Service Roads at grade on north & south side of the freeway main line. Both EB & WB US 290 Service Road signals are operated with a single controller as shown on the signal schematic shown on Figure 2, provided by Texas DOT.

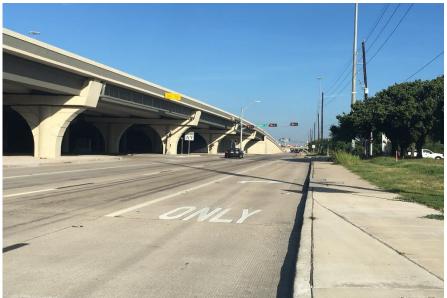
Figure 3. WB US 290 Service Road Approach

The WB approach is located downstream of the US 290 westbound off ramp and consists of 4 lanes (2 through, 1 right turn, 1 U-turn) with curb and sidewalk as shown in Figure 2.

Signal Visibility – Signal heads are visible from 1200'+ which is more than the MUTCD requirement of 390', as shown on Table 4D-2 below for posted speed of 40 mph. A "signal ahead" sign is installed at approximately 600' back from the stop bar. The traffic signal heads are horizontal-mounted and include "tunnel visors" and "backplates" for maximum visibility.

Pavement Conditions - A visual inspection of the pavement condition at the intersection showed no signs of significant wearing or cracking that could inhibit a driver's ability to stop while approaching the intersection. All required pavement marking (i.e. stop bar, lane lines, arrows, crosswalks) are present. However, the low contrast between the lighter color pavement surface and white paint is a concern but the markings are visible. Signing is adequate and in conformance with MUTCD.

Vehicle Detectors – three (3) sets Loop sensors are installed in the pavement on this approach. 6' x 20' presence sensors are installed at the stop bar in all lanes, 6' x 6' advance pulse sensors are installed at approximately 110' from the stop bar in all lanes, and 2, of 6' x 6' (in array) advance pulse sensors are installed at approximately 240' from stop bar. Pedestrian signal heads are installed for all permitted and marked crossings.

Signal Operation – Arrival at the signal is random due to separation distance of approximately 0.5 mile from previous signal at Beltway 8 and WB US 290 Service Road. However, the signal phasing and operation is not a contributing factor to red light running. Observed traveling speeds on WB US 290 Service Road appear to be higher than the posted limits. Higher than posted traveling speeds are caused by (1) the "open" condition of the road, (2) the separation distance from previous signal, and (3) motorists existing the freeway are traveling well in excess of the limits. Addition of a speed limit sign at the ramp merge area may help in settling the traffic on WB US 290 Service Road.

- Install a red light running enforcement camera.
- Install a speed limit sign.

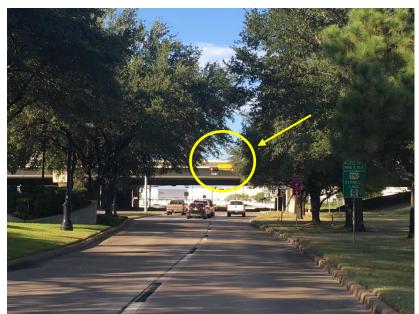
Figure 4. SB Senate Avenue Approach

The southbound Senate Avenue approach is a curbed 4-lane divided with no sidewalks and posted speed of 35 mph. The southbound approach is characterized by presence of mature trees planted on both shoulder side and the median, as depicted on Figure 4.

Signal Visibility – Trees obscure full visibility to the signal heads at 500' back from the stop bar. A "signal ahead" warning sign is present at 370' from the stop bar to warn motorists of the impending signal. Technically, at least one signal head is visible at 400' +/- which exceeds the required 325' distance at 35 mph approach speed. However, the visual distraction can impact the driver's behavior. The driver's view to the signal heads can be improved with selective tree trimming and frequent maintenance to ensure continued compliance with the visibility distance requirements.

Pavement Conditions - A visual inspection of the pavement condition at the intersection showed no signs of significant wearing or cracking that could inhibit a driver's ability to stop while approaching the intersection. All required pavement marking (i.e. stop bar, lane lines, arrows, crosswalks) are present. The low contrast between the lighter color pavement surface and white paint is a concern but the markings are visible. Signing is adequate and in conformance with MUTCD.

Vehicle Detectors $- 6' \times 20'$ vehicle loop sensors in presence mode are installed in all lanes and are functioning.

Signal Operation – Arrival at the signal is random. The signal phasing and operation is not a contributing factor to red light running.

- Trim trees and increase the maintenance frequency to ensure visibility of the signals.
- Install a red light running enforcement camera.

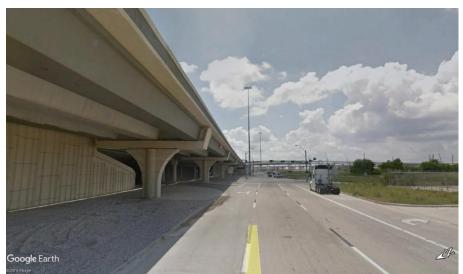
Figure 5. EB US 290 Service Road Approach

The EB approach is consists of 4 lanes (1 shared through & left, 2 through, 1 right turn) with curb and sidewalk as shown in Figure 5.

Signal Visibility – Signal heads are visible from 1000'+ which is more than the MUTCD requirement of 390', as shown on Table 4D-2 below for posted speed of 40 mph. The traffic signal heads are horizontal-mounted and include "tunnel visors" and "backplates" for maximum visibility.

Pavement Conditions - A visual inspection of the pavement condition at the intersection showed no signs of significant wearing or cracking that could inhibit a driver's ability to stop while approaching the intersection. All required pavement marking (i.e. stop bar, lane lines, arrows, crosswalks) are present. The low color contrast between the lighter color pavement surface and white paint is a concern but markings are visible. Signing is adequate and in conformance with MUTCD.

Vehicle Detectors – Three (3) sets Loop sensors are installed in the pavement on this approach. 6' x 20' presence sensors are installed at the stop bar in all lanes, and 2 sets of 6' x 6' advance pulse sensors are installed at approximately 110' and at approximately 240' from stop bar. Pedestrian signal heads are installed for all permitted crossings.

Signal Operation – Arrival is generally in "loose" platoon when released from the previous signal at FM 529, approximately 0.43 miles away. Since the signal is located after the US 290 on ramp, a portion of the traffic on the service road enters the main line freeway. The signal phasing and operation is not a contributing factor to red light running. Observed traveling speeds appear to be higher than the posted limits, thus, addition of a speed limit sign after the ramp area may help in settling the traffic on WB US 290 Service Road.

- Install a red light running enforcement camera.
- Install a speed limit sign.

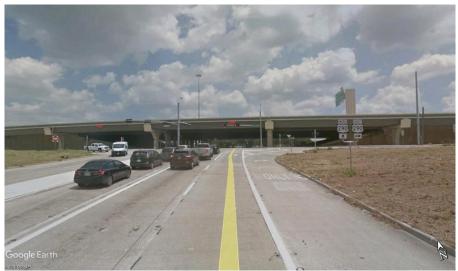
Figure 6. NB Senate Avenue Approach

The Northbound Senate Avenue approach has 4 lanes (3 through lanes & 1 right turn) divided with no sidewalks and posted speed of 35 mph, as depicted on Figure 6. There are 3 overhead bridge structures on this approach which limit sight to the signal, from outer lane.

Pavement Conditions - A visual inspection of the pavement condition at the intersection showed no signs of significant wearing or cracking that could inhibit a driver's ability to stop while approaching the intersection. All required pavement marking (i.e. stop bar, lane lines, arrows, crosswalks) are present but faded. The low contrast between the lighter color pavement surface and white paint pavement is a concern but markings are visible. Signing adequate and in conformance with the requirements of MUTCD.

Vehicle Detectors – 6' x 20' vehicle loop sensors, in presence mode, are installed in all lanes and are functioning.

Signal Operation – Arrival at the signal is random. The signal phasing and operation is not a contributing factor to red light running.

- Install a "signal ahead" sign prior to the structures on this approach.
- Increase the All-Red interval from 1.1 to 1.7 seconds for this phase (Ø2).
- Install a red light running enforcement camera.

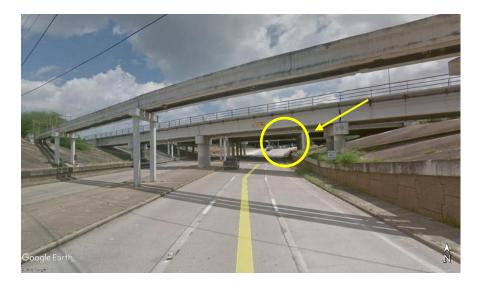
Figure 7. NB Senate Avenue Approach Before Overpass

Signal Visibility – This approach is on horizontal curve approaching the signal, in combination with 3 bridge overpasses, as shown in Figure 7. The signal heads are visible from approximately 600', which is higher than the 325' requirements for 35 mph speed limit. However, the traveling speeds are significantly higher than the posted speeds which may contribute to visibility concerns; specially from the outer lane. Recommend installation of a "signal ahead" warning sign in advance of the bridge to warn motorists of the impending signal.

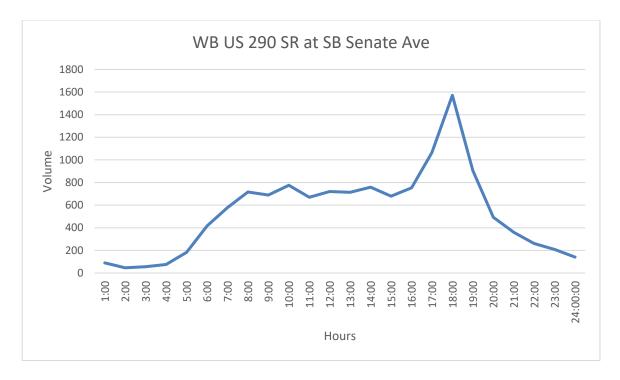
Figure 8. WB US 290 Service Road Daily Traffic Flow

24-hour directional traffic volume data were collected on Wednesday, August 29,2018; for all 4 approaches of the intersections. Figures 8-10 depict the daily flow variation and hourly volumes of the intersection approaches. Copies of the actual volume data are provided in the Appendix C of this report. As depicted, data indicates a distinct high morning peak in the EB US 290 Service Road and SB Senate Avenue, between the hours of 7:00 to 8:00 AM. The afternoon high peak occurs between 4:00 to 5:00 PM on WB US 290 Service Road and NB Senate Avenue. The afternoon peak hour is the heaviest hourly volume.
